**Flood Control Project Maintenance
Levee Inspections****LMA District Cover Sheet****Spring 2015 Levee Inspection Results****California Department of Fish and Game Shea Levee**

Spring 2015 Levee Inspection Results

California Department of Fish and Game Shea Levee

Waterway			Bank	Unit Miles
Unit No. 01 Sacramento River			Left	0.30
	Spring (March - May)	Summer (June - August)	(September - November) Fall	Winter (December - February)
Unit Maintenance Rating (Fall Only)				
Date of Inspection	04/08/2015 - 04/08/2015			
DWR Inspector	Bob Duffey			
Accompanied By	Michael Harris Department of Fish and Game

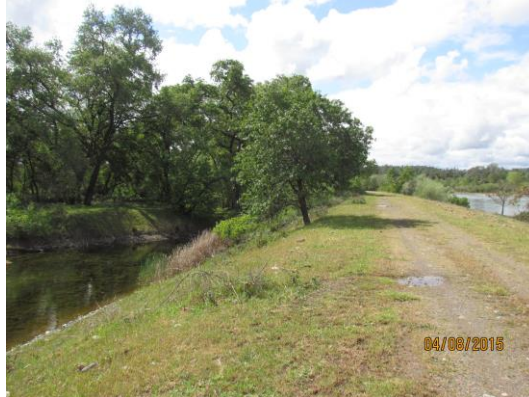
Photo 1 of 1 : SP_2015_NA0018_269_2_20150420_00006.jpg

LM Start	0.00	Rating **	M	Issue No.	2
LM End	0.07	Issue Type +	Ma	Location *	LS
Category	Earthen Levee			GPS Latitude/Longitude	
				Start	End
Item	Vegetation			40.508138 °	40.508138 °
				-122.363480 °	-122.363480 °
DWR ID	DWR_NA0018_01_s_2012_2				
Action/Comments					
Remove the wild growth other than native grasses from the levee slopes.

View of the levee with no maintenance done.

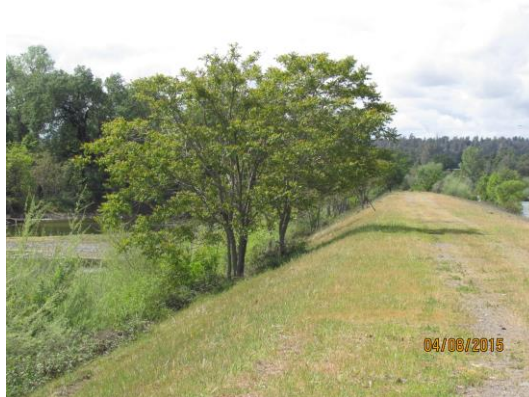
Photo 1 of 1 : SP_2015_NA0018_269_9_20150420_00007.jpg

LM Start	0.00	Rating **	M	Issue No.	9
LM End	0.21	Issue Type +	Ma	Location *	LS
Category	Earthen Levee			GPS Latitude/Longitude	
				Start	End
Item	Trim / Thin Trees			40.509012 °	40.510649 °
				-122.362609 °	-122.360945 °
DWR ID	DWR_NA0018_01_f_2012_9				
Action/Comments					
Thin trees to allow visibility of the ground and room to flood fight. Inspector Comments: Fish and Wildlife Service has not completed any maintenance.

Remove the small trees along the landside slope.

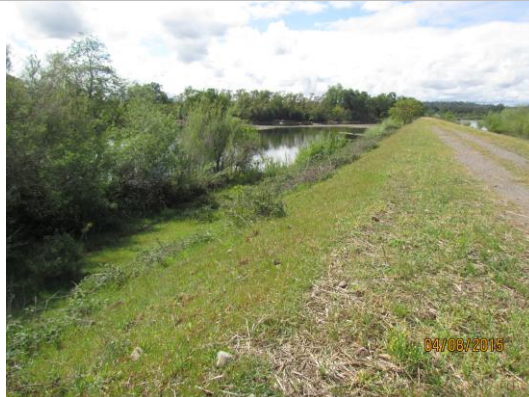
Photo 1 of 1 : SP_2015_NA0018_269_1_20150420_00008.jpg

LM Start	0.10	Rating **	M	Issue No.	1
LM End	0.30	Issue Type +	Ma	Location *	LS
Category	Earthen Levee			GPS Latitude/Longitude	
				Start	End
Item	Vegetation			40.511185 °	40.510670 °
				-122.360553 °	-122.361203 °
DWR ID	DWR_NA0018_01_s_2012_1				
Action/Comments					
Remove the wild growth other than native grasses from the levee slopes.					
Inspector Comments: Fish and Wildlife Service has not completed any maintenance.

View of the blackberries and other vegetation along the landside slope.

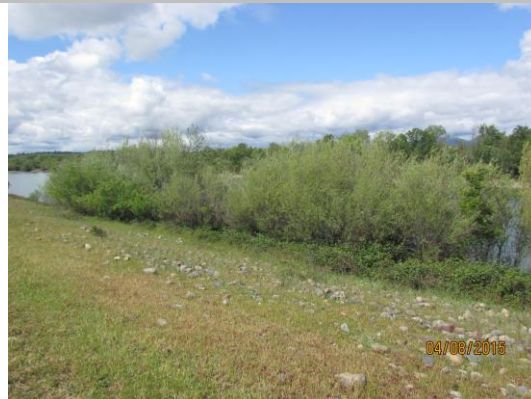
Photo 1 of 1 : SP_2015_NA0018_269_4_20150420_00009.jpg

LM Start	0.21	Rating **	M	Issue No.	4
LM End	0.26	Issue Type +	Ma	Location *	WS
Category	Earthen Levee			GPS Latitude/Longitude	
				Start	End
Item	Trim / Thin Trees			40.511518 °	40.508234 °
				-122.360100 °	-122.363430 °
DWR ID	DWR_NA0018_01_s _ 2012_4				
Action/Comments					
Trim and thin trees to allow visibility of the ground and room to flood fight.

Trim the trees along the waterside slope.

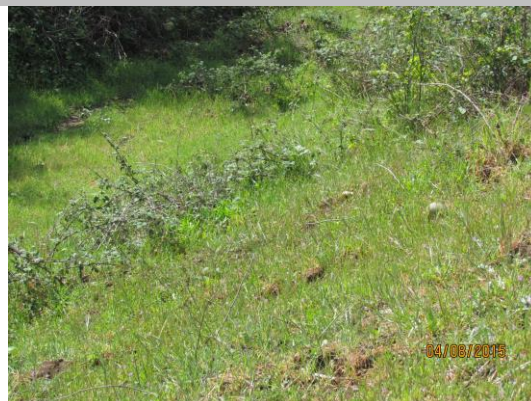
Photo 1 of 1 : SP_2015_NA0018_269_6_20150420_00010.jpg

LM Start	0.22	Rating **	M	Issue No.	6
LM End	0.30	Issue Type +	Ma	Location *	LS
Category	Earthen Levee			GPS Latitude/Longitude	
				Start	End
Item	Animal Control			40.510671 °	40.511185 °
				122.360944 °	122.360553 °
DWR ID	DWR_NA0018_01_s _ 2013_6				
Action/Comments					
Repair the levee slope damaged by livestock and prevent large animal access.					
Inspector Comments: The livestock damaged the L/S slope.

View of the livestock erosion along the landside slope.
